Docket No. 217 – Development and Management Plan Inspection

Date: November 23, 2005

Location: 115 kV Underground Route

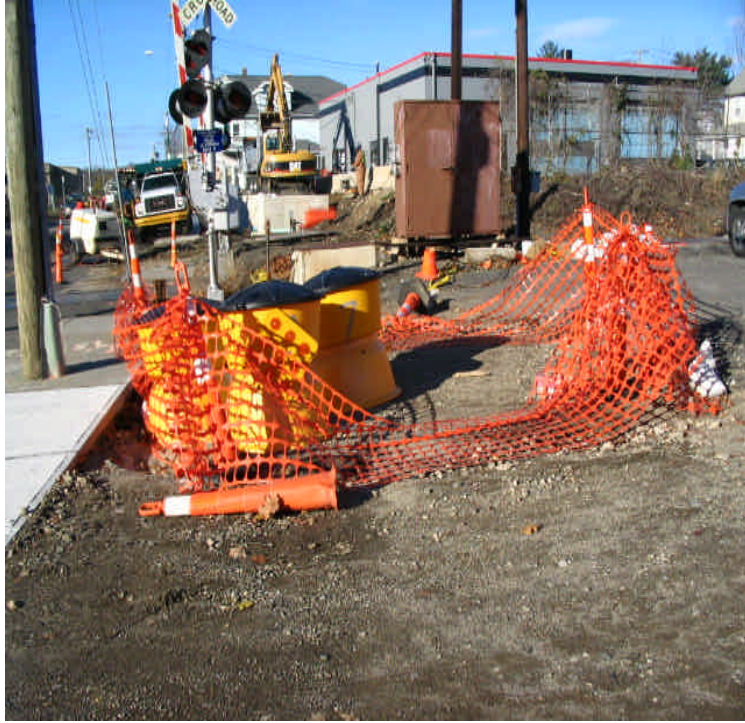
115kV (Broad Street): Photo on the left shows the receiving pit area of the railroad jack and bore closed up and ready for final stabilization. Photo on the right shows the trench through the Shell parking lot with curbing restored. Continue to restore grassed area as well. 11/23/05

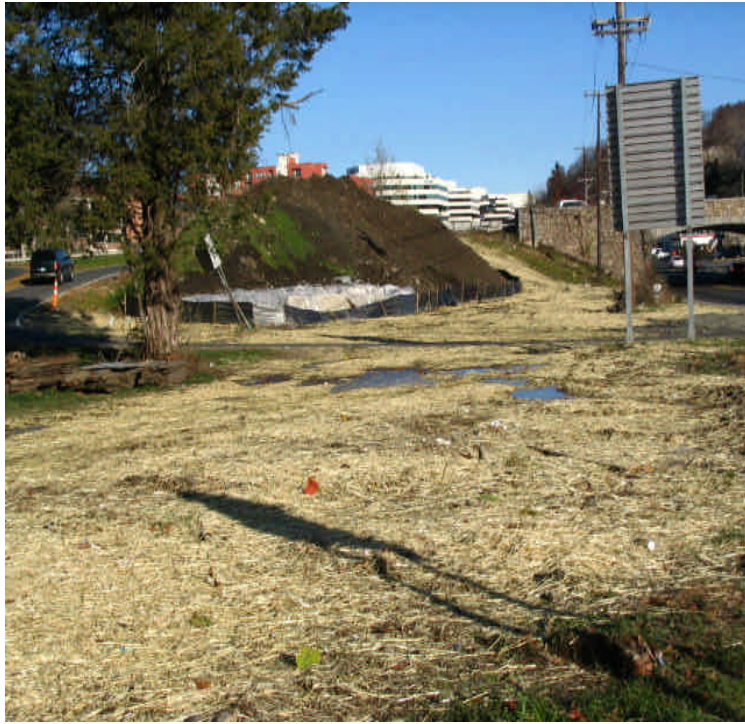
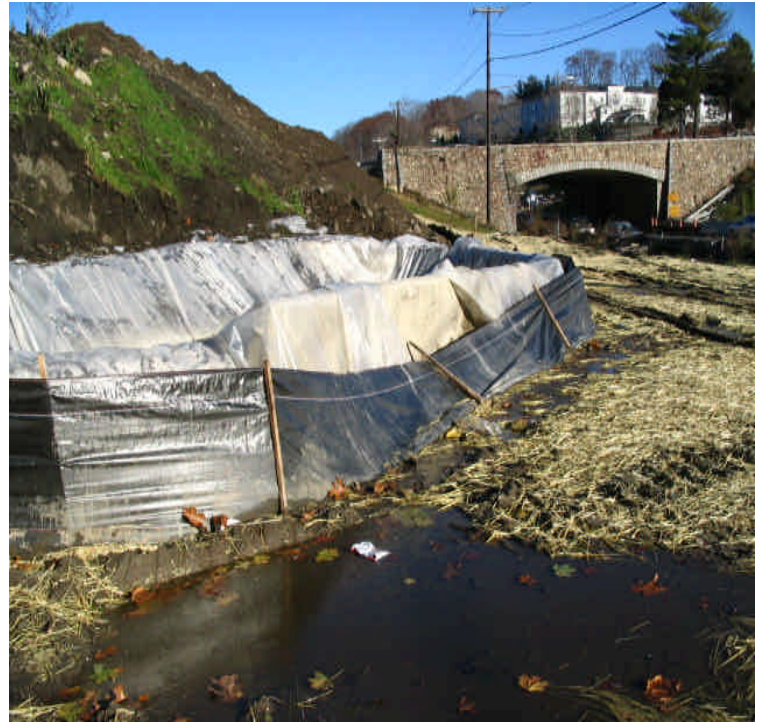
115kV (Rt.7). Both photos show views of the concrete washout area and a previous stockpile area which have been mulched and appear to have limited use by the project any longer. 11/23/05

- Henckels and McCoy- a contractor separate from the contractor was working on a gas line in the vicinity of the railroad. 11/23/05 -Trenchwork is largely complete. 11/17-11/23/05 - The Merritt Cloverleaf concrete washout area and adjacent stockpile area have been mulched as this area has limited remaining use from this project. 11/23/05	- None at this time. 11/23/05 - Continue to clean up roadsides and restore features. 11/23/05 - None at this time. Keep controls maintained if it will still be used. 11/23/05
Contaminated Soils	-Soil disposal is no longer a major component of the project as most areas of trench work are completed. Clean process was brought in to bring roadways to grade. All remaining soil work is still being handled as approved. 11/23/05	- All soils appear to be handled appropriately. 11/23/05
Adjacent Wetlands and Waterways	-The stream near Sara's Way off Rt. 58 remains clear and banks are free from erosion. 11/23/05	- None at this time. Continue to monitor for final vegetative stabilization. 11/23/05

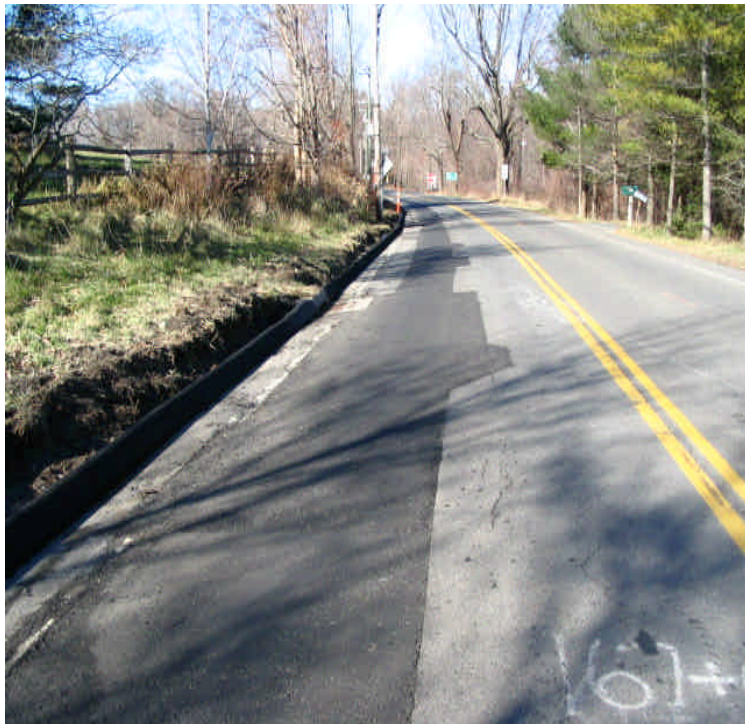
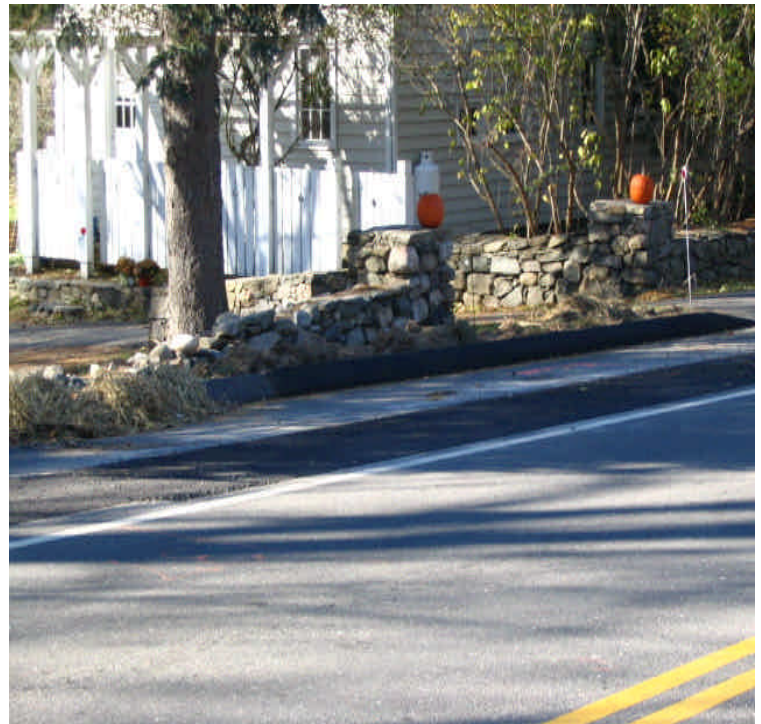
Areas of Inspection	Observation	Recommended Action
Rt. 107 (Lonetown Rd) Broad Street and ROW, Norwalk	- Active roadway repair work was ongoing. Catch basins appeared to be protected and curbing is being installed. 11/23/05 - The storage area south of the 90 degree turn on Rt. 107 had some very worn but mostly functional silt fence in place. 11/23/05 - The bank cut area at Lois Lane (vault #8) here should be restored with seed and mulch. 10/5-11/23/05	-In general, monitor road work and make sure no soil is stockpiled. Restore the roadside if equipment causes disturbance during this phase. 10/19-11/23/05 - Monitor and repair the fence here as long as storage continues in this area. 11/23/05 - Restore the area if work is complete. 10/5-11/23/05

115kV (Rt 107 and Rt. 58). Both photos show typical permanent roadway restoration to grade with curbing being formed. 11/23/05

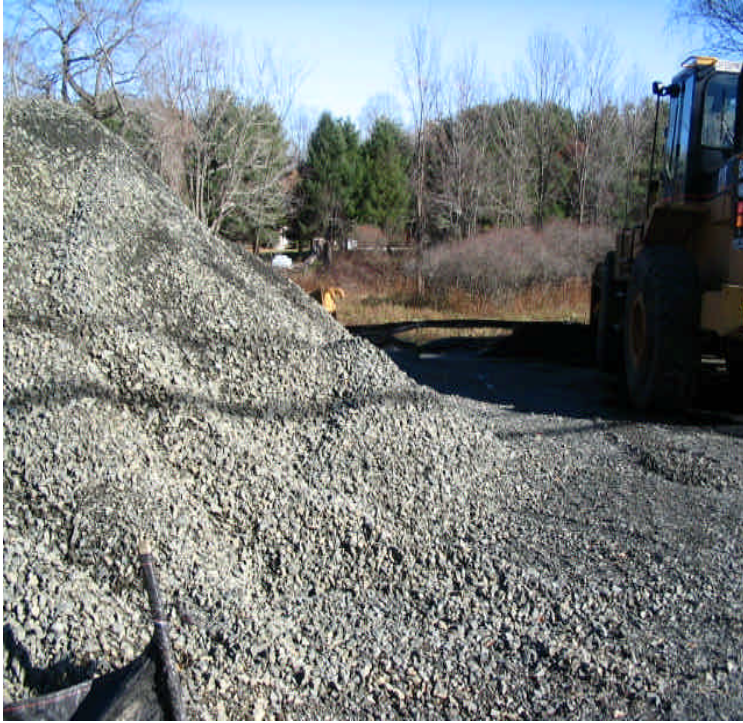
115kV: (Rt. 107 and 58 Storage areas) Photo on the left shows the storage area near the Rt. 107 90 degree turn where the silt fence is becoming frayed but is currently functional. Photo on the right shows the storage area at Sunset Hill Rd. where silt fence is in good shape. 11/23/05

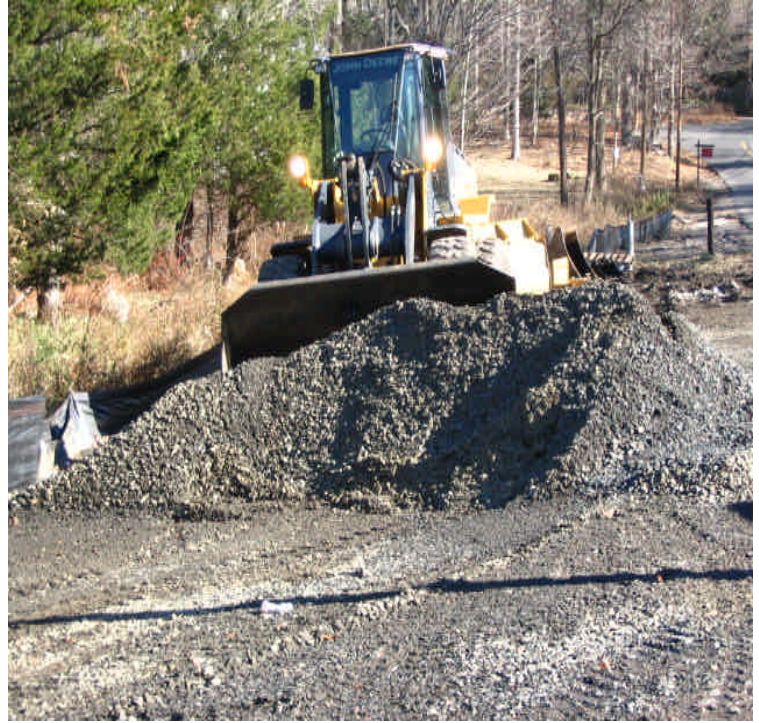
- Silt fence at the Putnam Park storage area near the pond continues to be in good repair. 10/27-11/23/05	- None at this time. 11/23/05
	- The Sunset Hill Rd. storage area silt fence looks better and trench boxes have been removed. 11/23/05	- Keep erosion controls in place as long as the stone stockpile and bare soil remains. 11/23/05
Gallows Hill Road	- The roadway and adjacent work areas are largely stabilized. 11/23/05	- None at this time 11/23/05

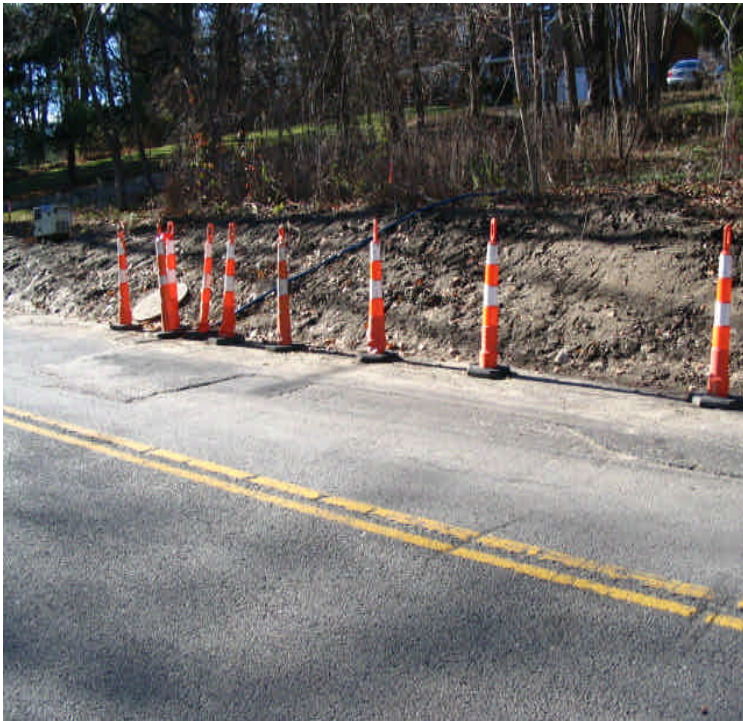
115kV: (Rt. 107 and Rt. 58) Photo on the left shows the bank cut remaining near Lois Lane (vault #8) Mulch is needed here when practicable. Photo on the right shows the typical set-up at vaults for proofing and future cable-pull. 11/23/05

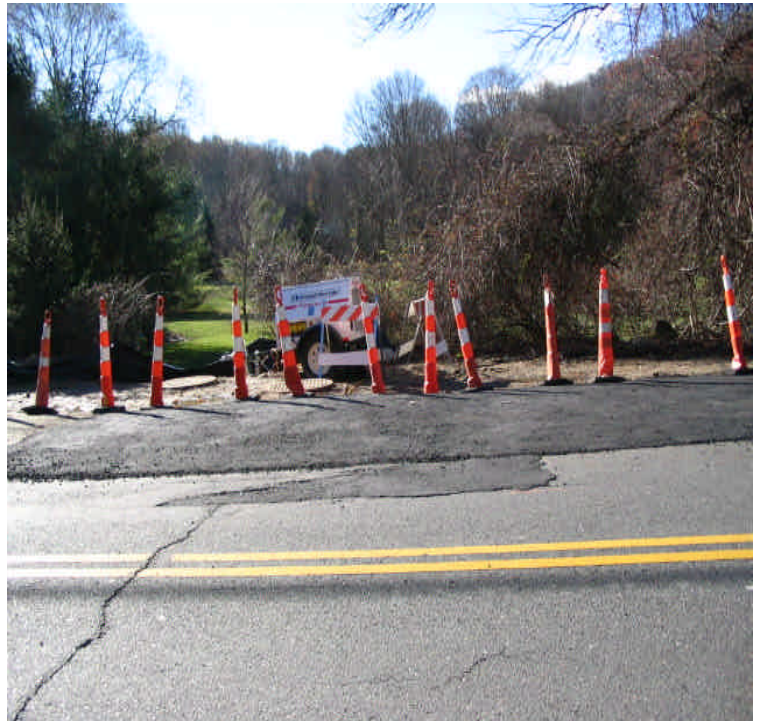
- Working to dewater and prepare the vaults was occurring in several locations. 11/23/05	- Restore the edge of roadway with seed/mulch if necessary following equipment access. 11/23/05

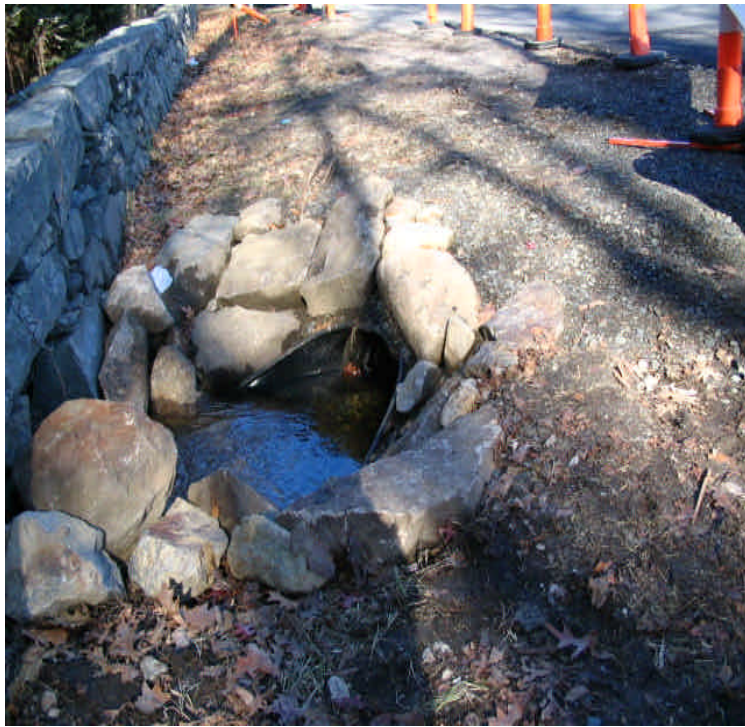
- One vault setup was located near a stream at Putnam Park. The stream was running very clear but bare soil is located around it. 11/23/05	- Monitor the area for any erosion issues and mulch the area when vault work is done. 11/23/05

115kV (Rt. 58 and Hoyts Hill Transition Structure): The photo on the left shows a stream crossing near a vault at Putnam Park which had very clear water. Photo on the right show risers being installed along the pole structure. 11/23/05

Areas of Inspection	Observation	Recommended Action
	- A small stream crossing near Putnam Park at a vault setup also remains clear at this time. 11/23/05	- Monitor as bare soil remains around the stream. 11/23/05
Staging, Storage, and Parking Areas	<p>-The Merritt cloverleaf area has been mulched and controls remain well installed. 11/23/05</p> <p>- The Redding Yard has very limited use from this project any longer but controls remain in good shape. 11/23/05</p> <p>- At the storage area off Rt. 58 near the Putnam Park entrance, controls remain in good shape with adjacent wetlands remaining un-impacted. 11/23/05</p> <p>- The silt fence at Sunset Hill Rd. storage yard is in good shape and the trench boxes have been removed. 11/23/05</p> <p>-The area across from the country club near the 90 degree turn on Rt. 107 is worn but functional. 11/10-11/23/05</p>	<p>- Continue to monitor and maintain if used any further for this project 11/23/05</p> <p>- None at this time. 11/23/05</p> <p>-Retain the silt fence here due to the proximity of the pond while the yard still in use. 11/23/05</p> <p>- Maintain fence as long as the areas are being used but it can be pulled if the storage areas are mulched/restored. A stone pile is in place at both locations. 10/27-11/23/05</p>

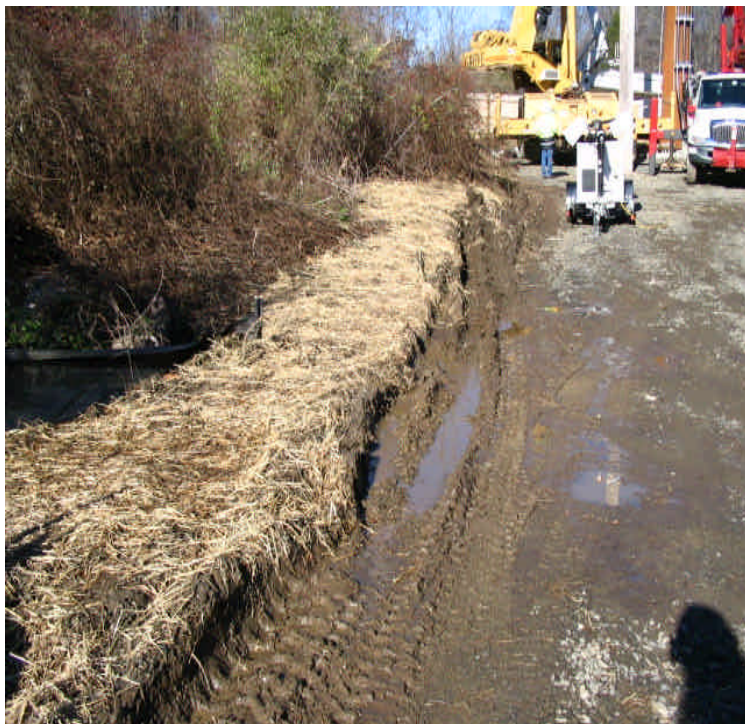
Areas of Inspection	Observation	Recommended Action
Hoyts Hill Riser Transition Structure (Off Rt. 58)	- Work returned to install risers along the pole structure and equipment access has created ruts along the sides of the drive in the mud. 11/23/05	- The ruts should be graded and mulch added to the area when the equipment access is complete. 11/23/05
Route 58	- Most catch basins near the work areas are being consistently placed with either haybales or fabric and are well protected as the road is being brought to grade. Curbing was being restored as well. 11/23/05	In general, contain slurry or mobile sediment to work areas and street sweep the road extent including the gutters, regularly and maintain controls on all catch basins and inlets. 11/23/05

115kV (HH and Bethel Ed. Park): Photo on the left shows ruts along the access road to Hoyts Hill structure. Photo on the right shows the northern portion of the ROW at Bethel Ed where some equipment access has created muddy conditions. 11/23/05

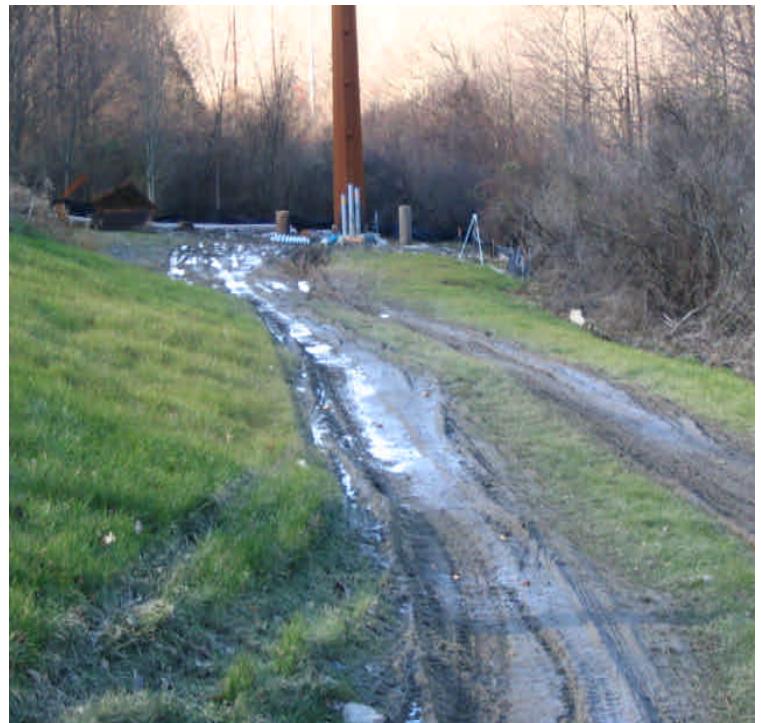
Bethel Educational Park	<ul style="list-style-type: none"> - The northern ROW showed some ruts/muddy conditions from equipment access but is mostly stable. 11/23/05 - A small washout was also noted along the southern ROW access drive. 11/10-11/23/05 - Most silt fence along this portion of the ROW has been pulled. 11/23/05 - The slope at the southern end of the ROW remains fairly stable. 11/23/05 	<ul style="list-style-type: none"> -Some mulch should be placed on ruts when access needs are complete. 11/23/05 - The gully should be placed with stone to prevent sedimentation. 11/10-11/23/05 - If necessary, place mulch and seed or less preferable, stone along the slope to further stabilize. 11/23/05
